TWR-17371

Space Shuttle Development Motor No. 9 (DM-9) Final Test Report

Thiokol CORPORATION
SPACE OPERATIONS

DM-9 Static Test (23 Dec 1988)--Fired Under Extreme
Environmental Conditions

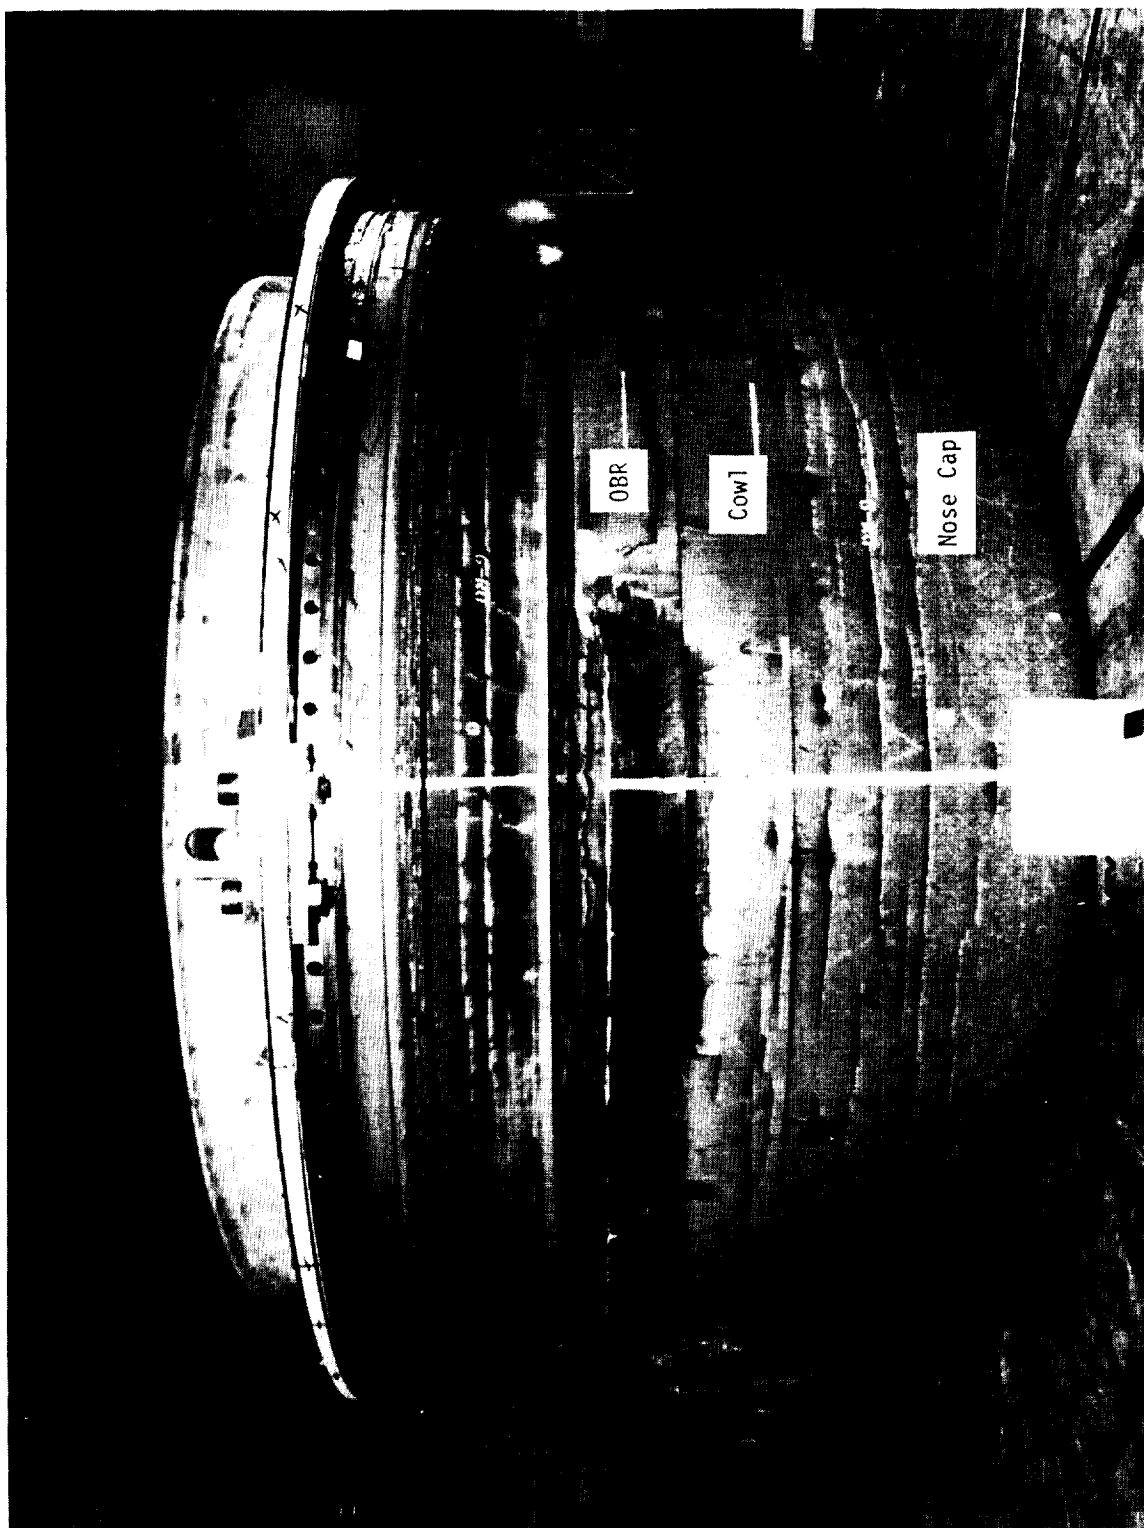
Figure 7.5-9. DM-9 Nozzle Overall View (0 deg)

Charred CCP plies wedged out on the nose cap aft end intermittently around the nozzle circumference. Figures 7.5-9 through 7.5-12 and 7.5-19 show views of the wedged out areas. The poppedup and missing material occurred over the aft 2 to 2.5 in. of the nose cap and was a maximum of 0.5 in. deep radially at the cowl interface. Plies exposed after the material wedged out showed signs of heat effect,

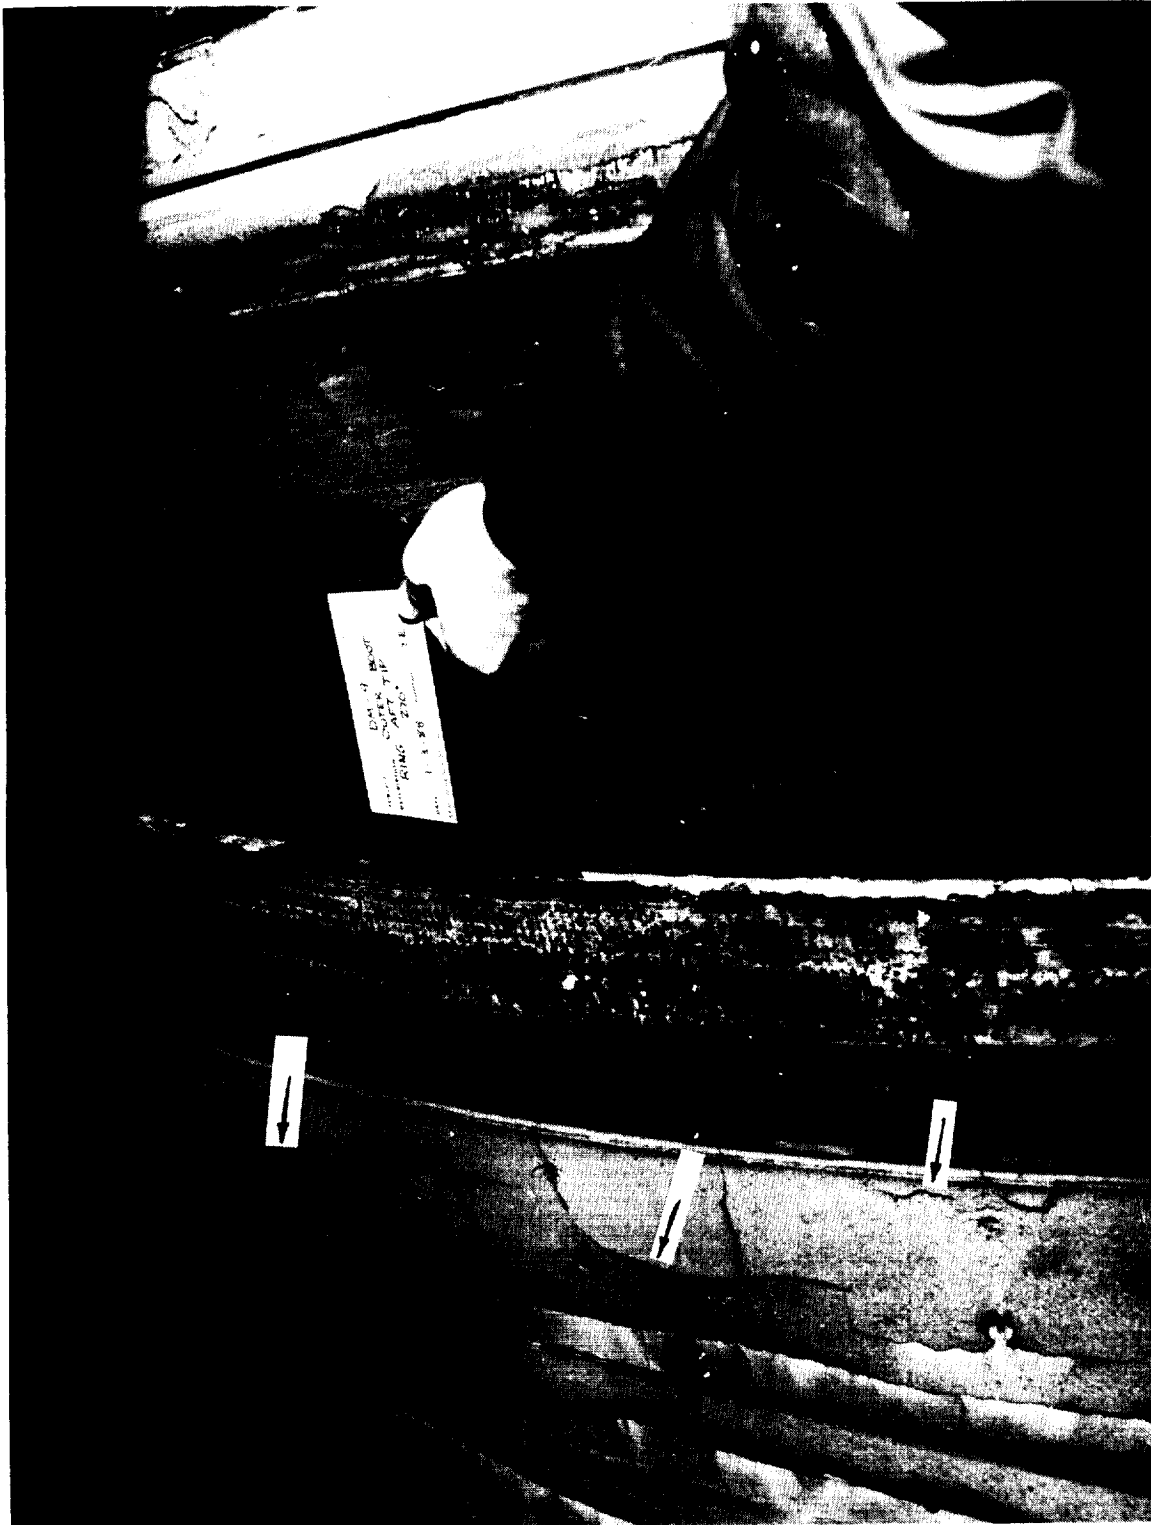
Figure 7.5-54. DM-9 Cowl Ring Irregular Erosion Patterns (270 deg)

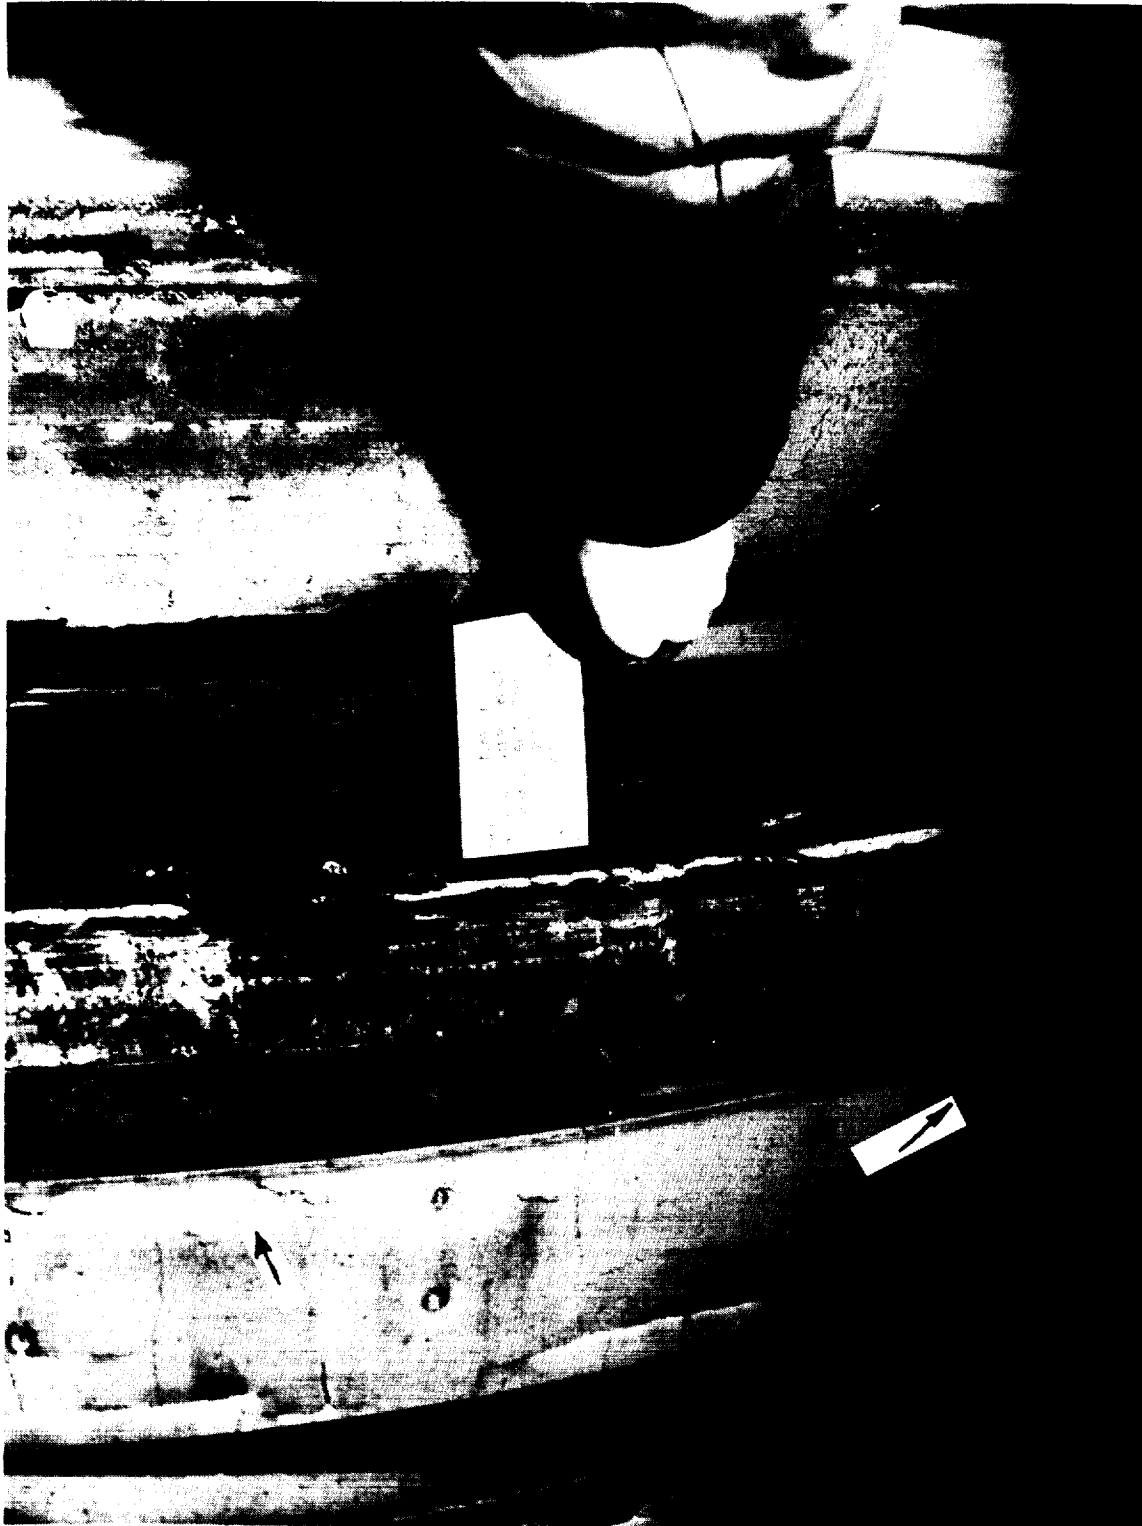
Figure 7.5-55. DM-9 Cowl Ring Irregular Erosion Patterns (300 deg)

The cowl ring showed cross-ply cracks extending axially through the port vent and shear pinholes. Axial cracks were also observed spaced between ventholes. These axial cracks have occurred on all previous nozzles and have been shown to be isolated within charred CCP material only.

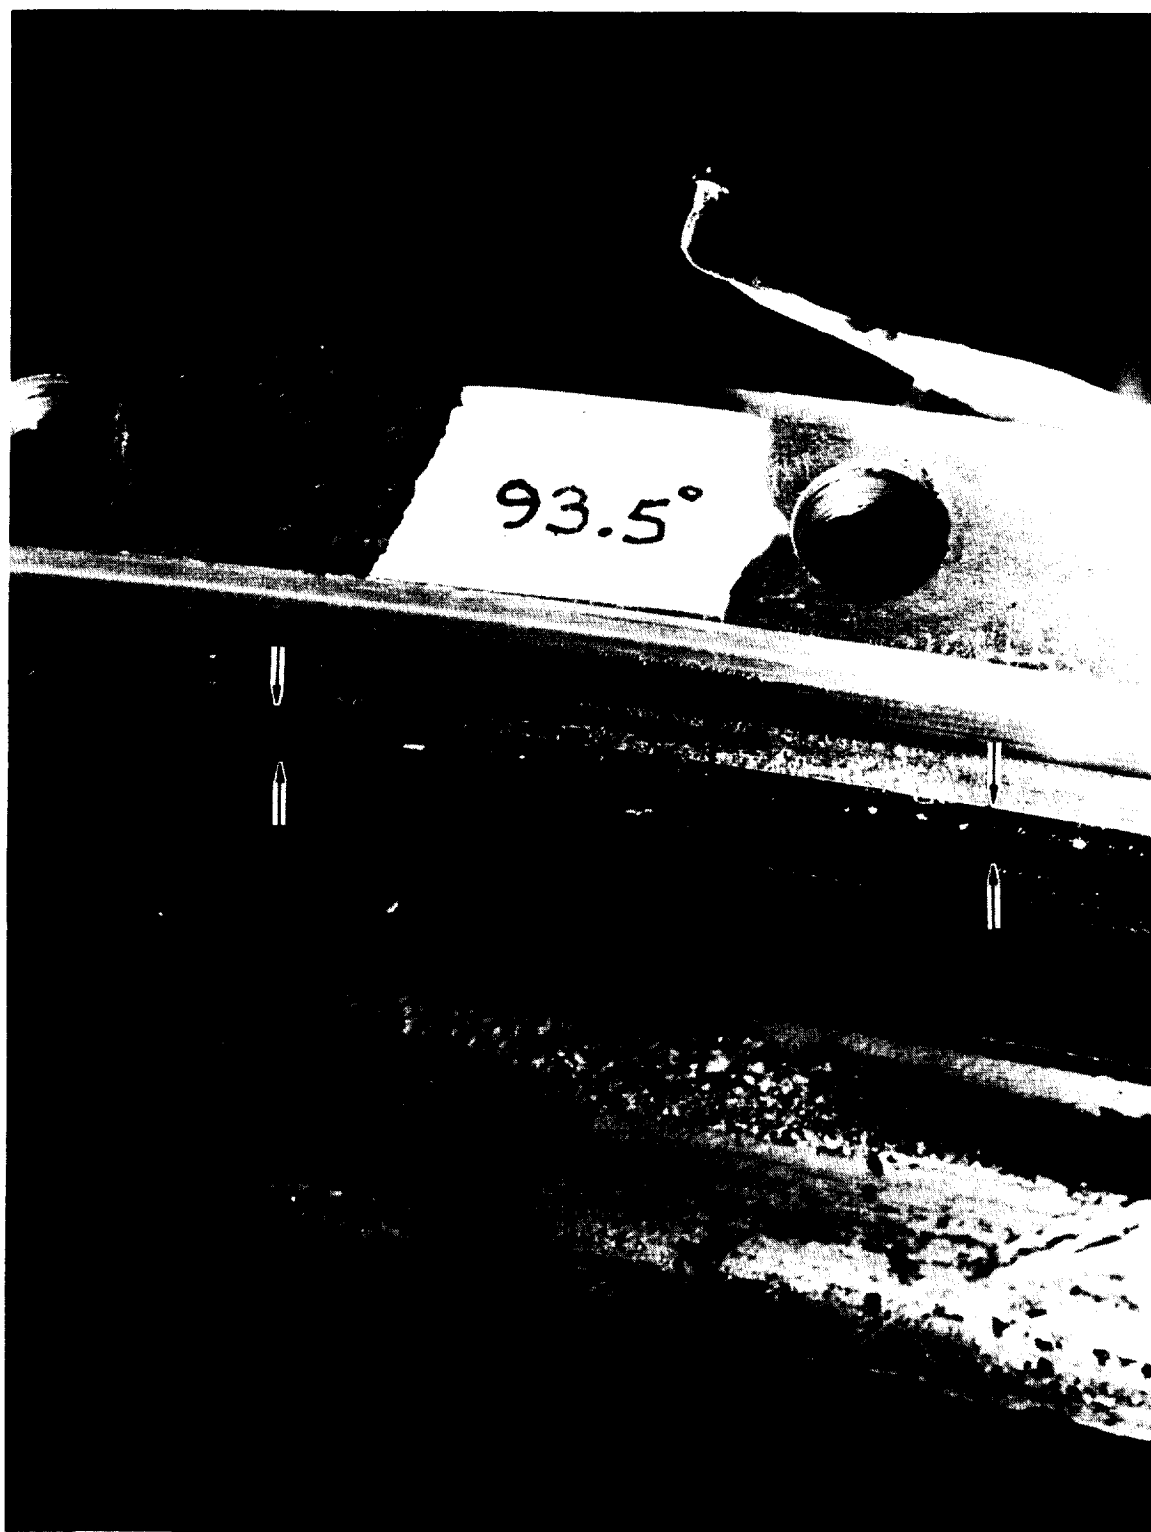
Figure 7.5-82. DM-9 Aft Exit Cone Polysulfide Backfill (93 deg)

Figures 7.5-82 through 7.5-83 show views of the polysulfide backfill at the forward aluminum shell bondline. No adhesive failure was evident between the polysulfide and housing or between the polysulfide and GCP overwrap. The surface bubbles/voids within the polysulfide were present in the pretest. There was no evidence of flow within or adjacent to the shell bondline.

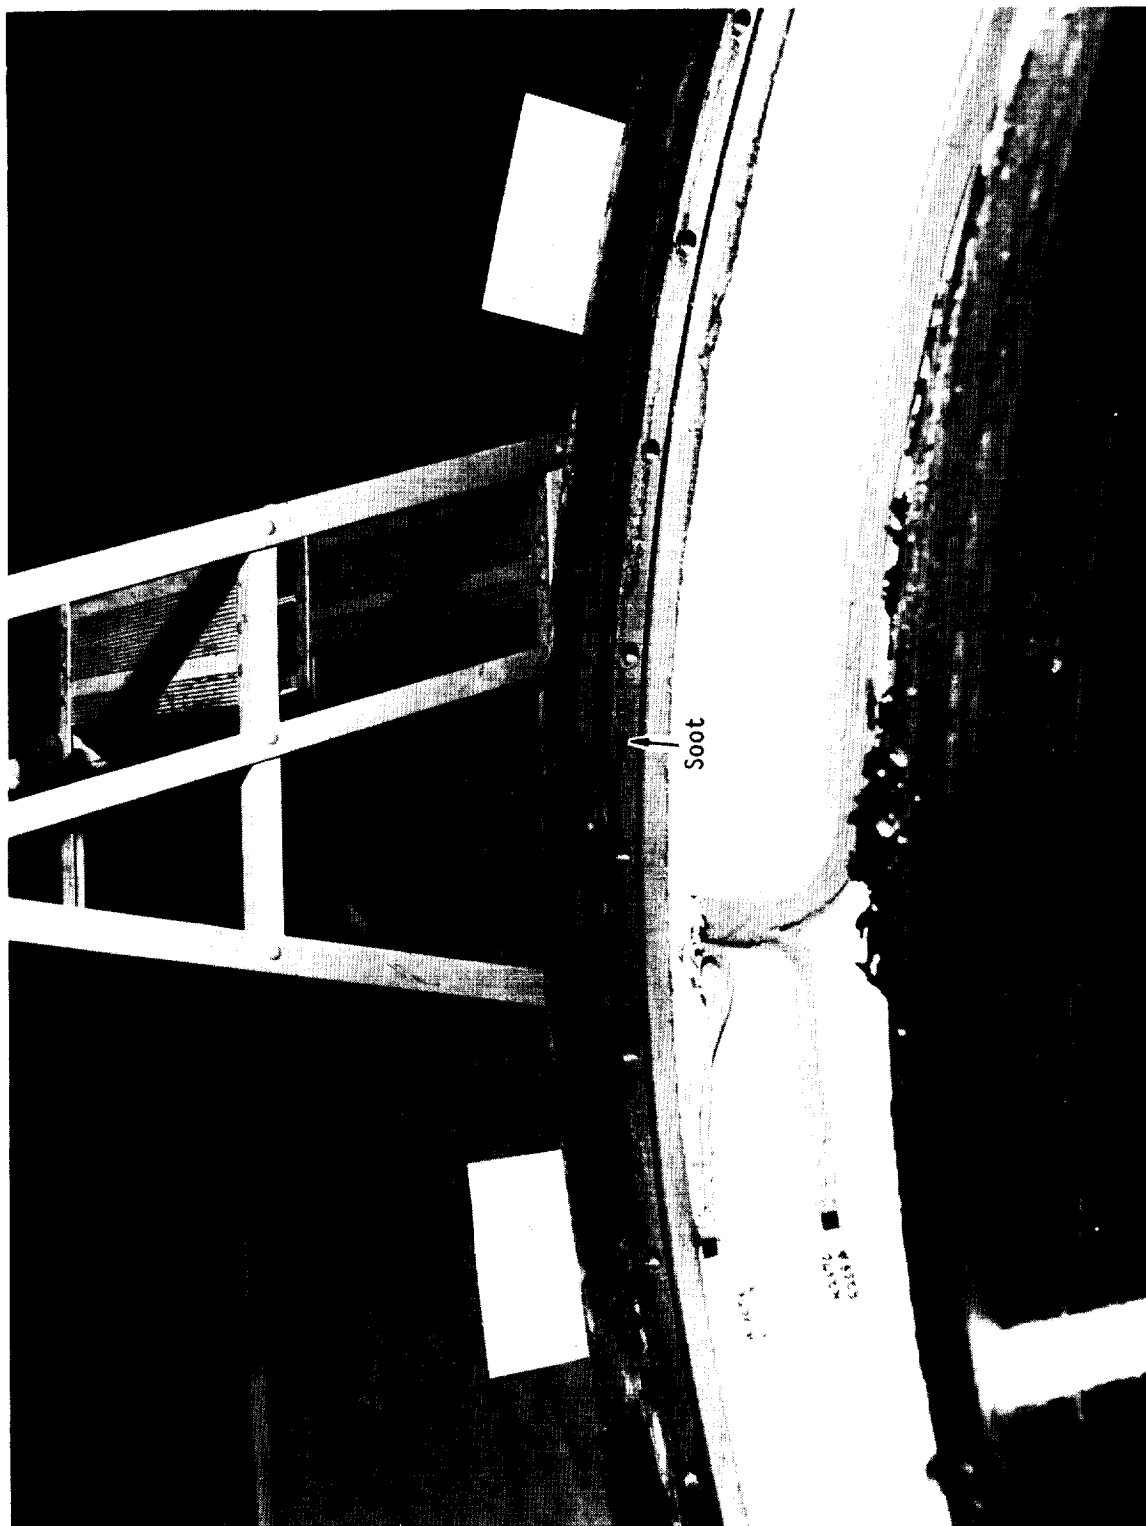
Figure 7.5-92. Nose Cap Aft End at 60 to 90 deg Showing Soot

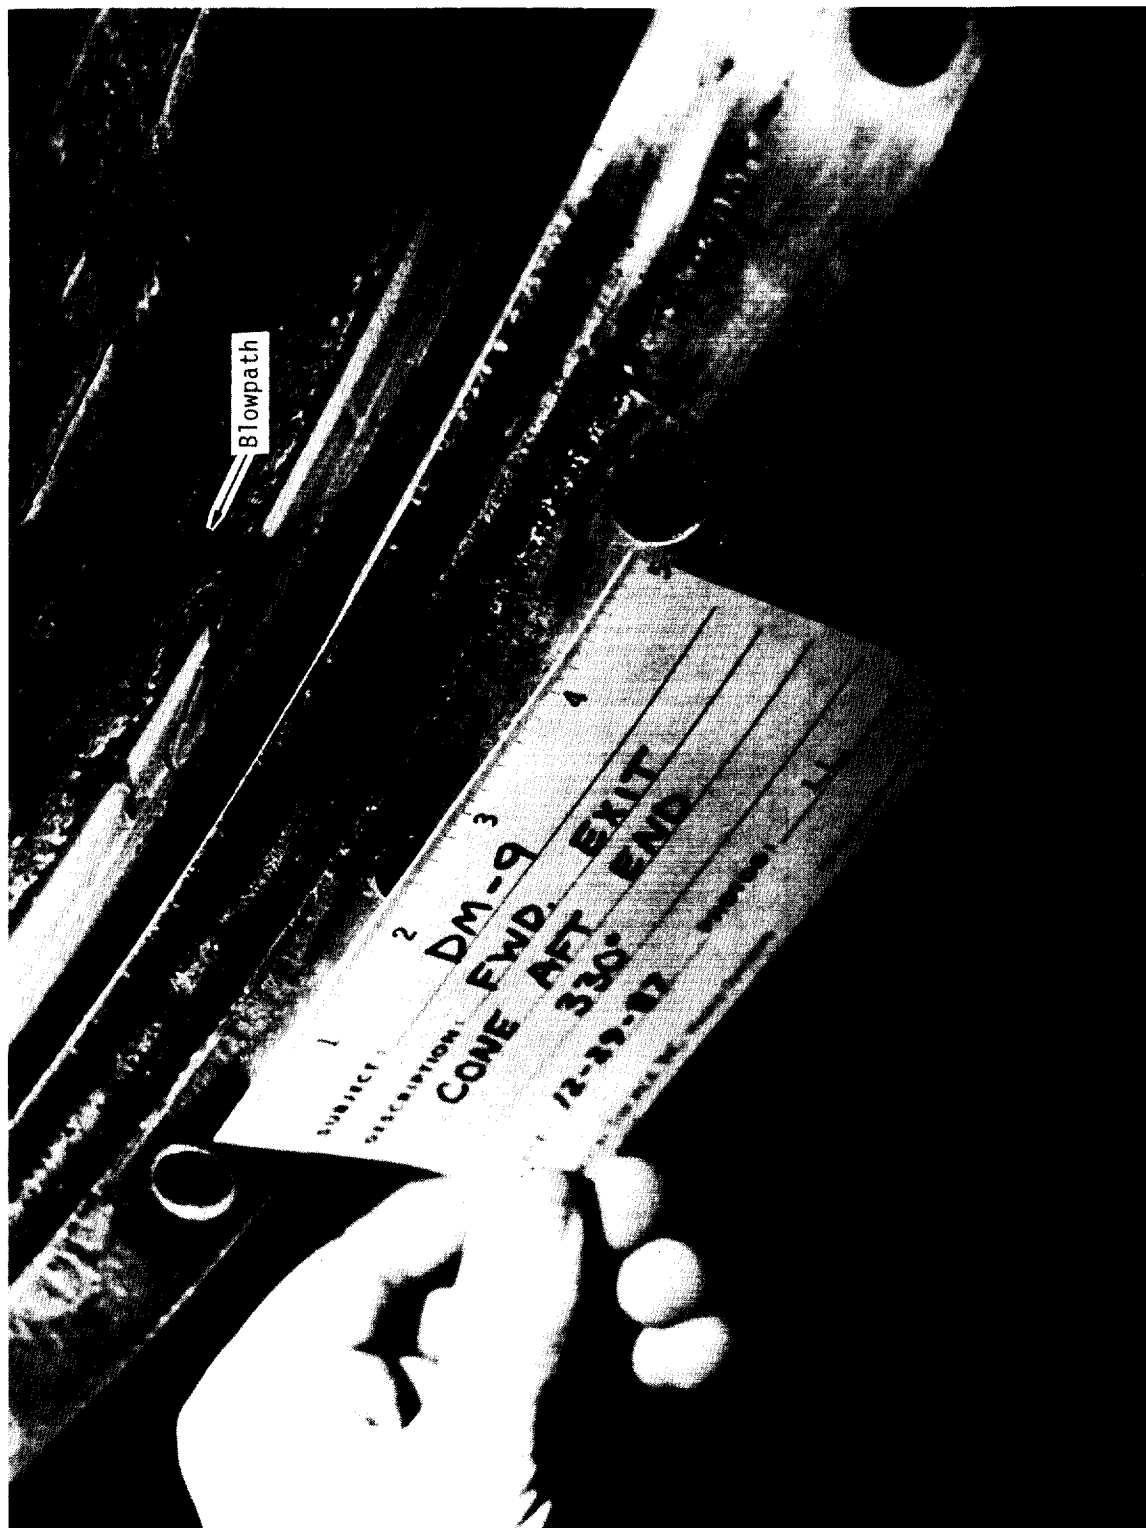
Figure 7.5-104. Forward Exit Cone Aft End at 330 deg Showing Blowpath

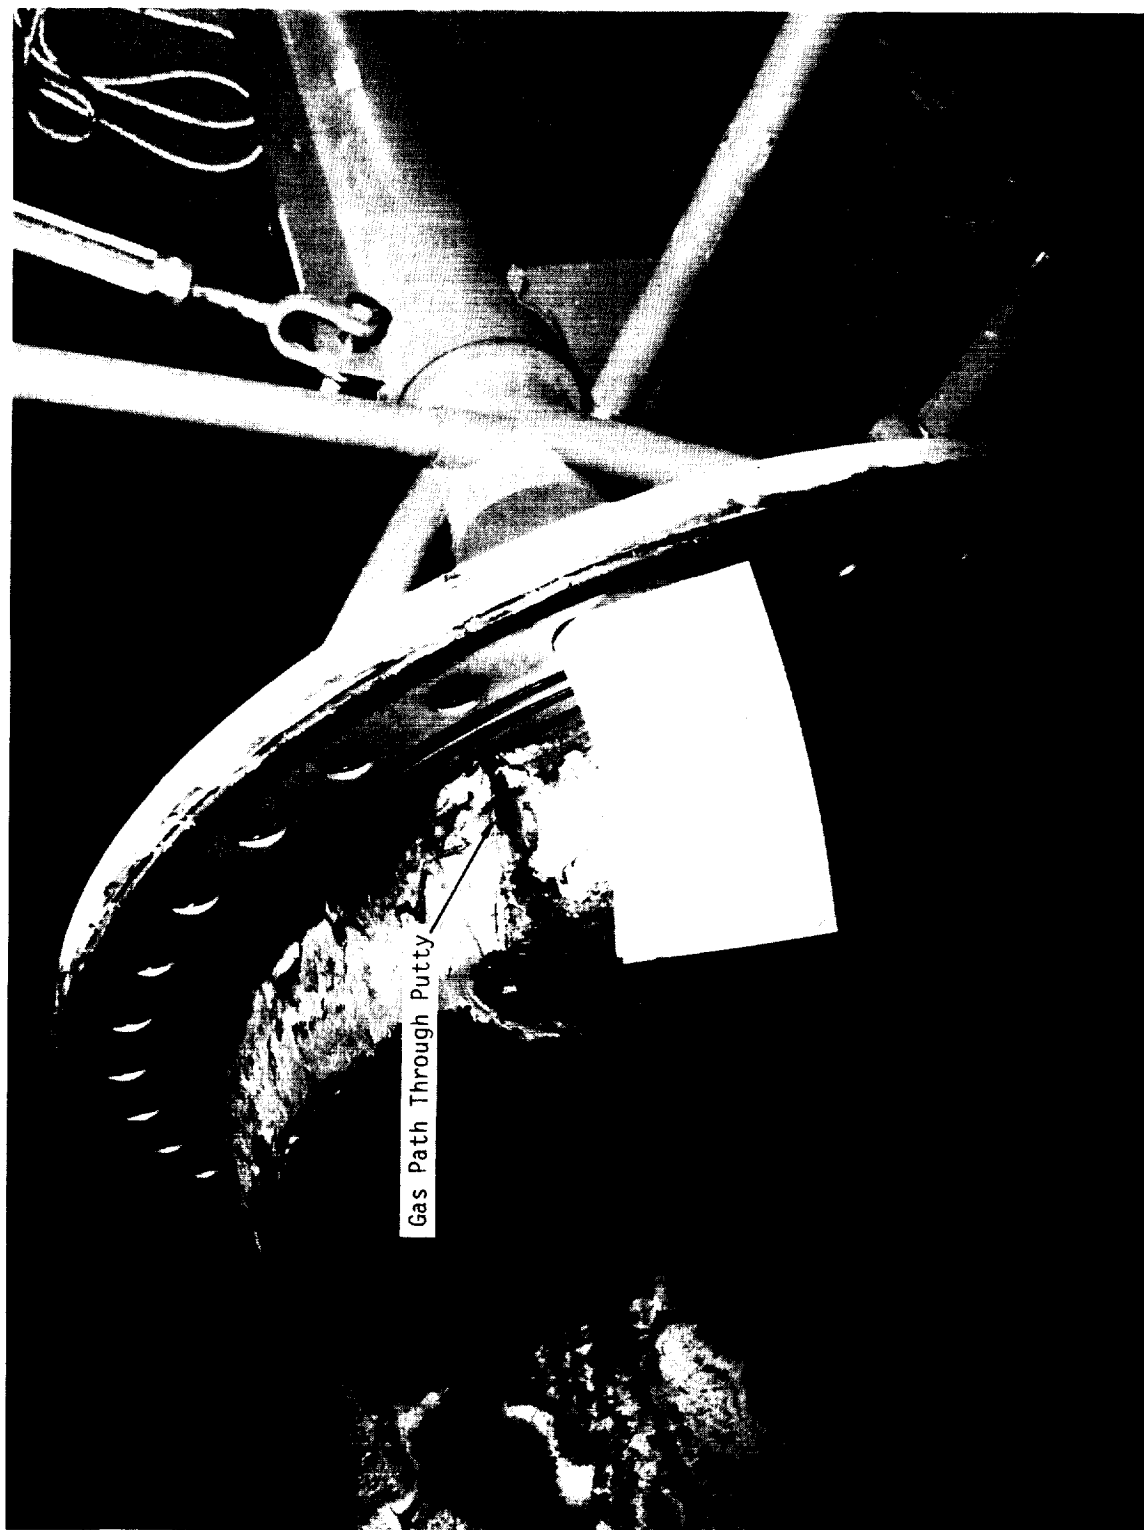
Figure 7.8-6. DM-9 Igniter-to-Forward Dome Joint

All seals functioned normally. There was a deposit of combustion products on the edge of the metal retainer of the outer gasket where gas bypassed the vacuum putty at the joint (Figure 7.8-6); however, the primary seals held so that there were no deposits of combustion products between the seals (Figure 7.8-7). The chamber and adapter exhibited no indication of overheating, and there were no deposits of combustion products between the seals. The rubber seals on the DM-9 gaskets showed no evidence of overheating. There was a gas path in the adapter-to-chamber putty (Figure 7.8-8). Combustion products were deposited on the inside edge (adapter side only) of the inner gasket metal retainer (Figure 7.8-9). This anomaly has been seen on previous motor tests and has never resulted in damage to the rubber seals. No erosion or blowby of the primary seal was observed.
